## A Survey of Thatched Buildings in Scotland

Thatch Survey of Scotland  
2014-15

A photographic survey of thatched buildings in Scotland, surveyed between May 2014 and August 2015 by Zoe Herbert (SPAB Scotland Officer), on behalf of the Society for the Protection of Ancient Buildings.

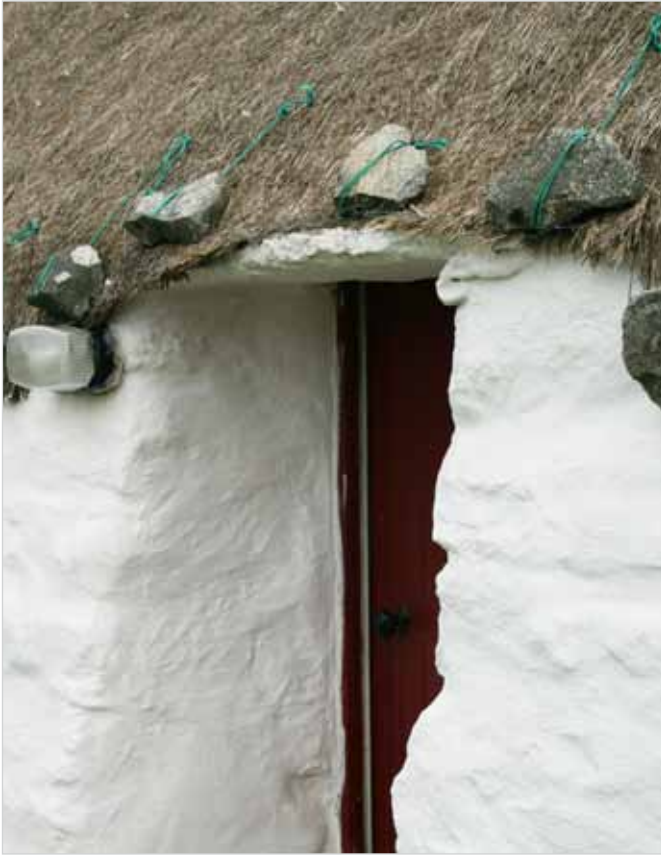
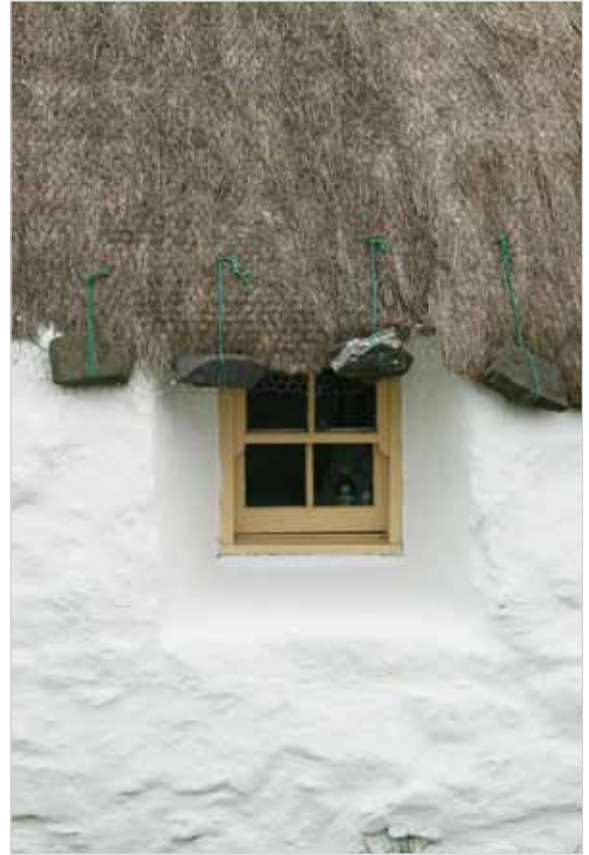
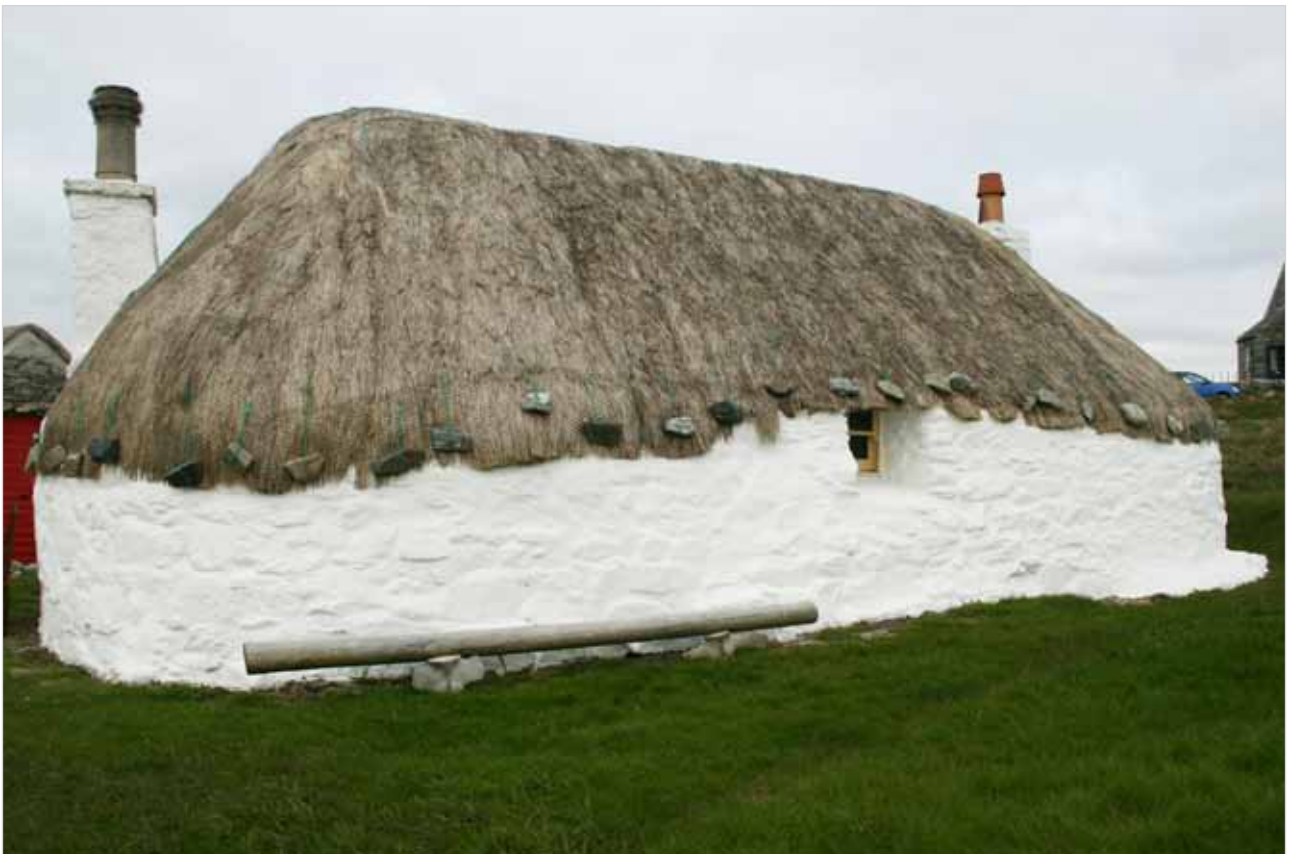
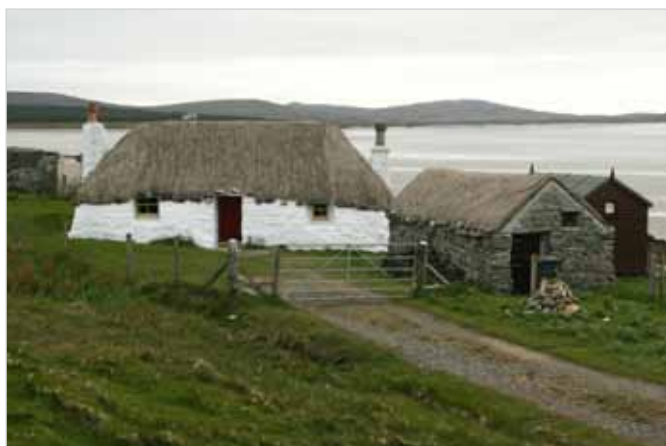
Struan Cottage – Western Isles

Additional Notes: ..... Probably 19th-century single-storey cottage, listed as having a '*muran* *thatch roof*, secured above inner wallhead by stone weights'. The marram-thatched roof has a continuous thatched ridge and the entire thatch has been netted and weighted along the eaves by stones secured to the netting with string. The cottage has been modernised internally and is currently used as holiday accomodation. To the north-east of the building there is a thatched outbuilding (survey number 255), which appears to be in use as storage for the cottage.

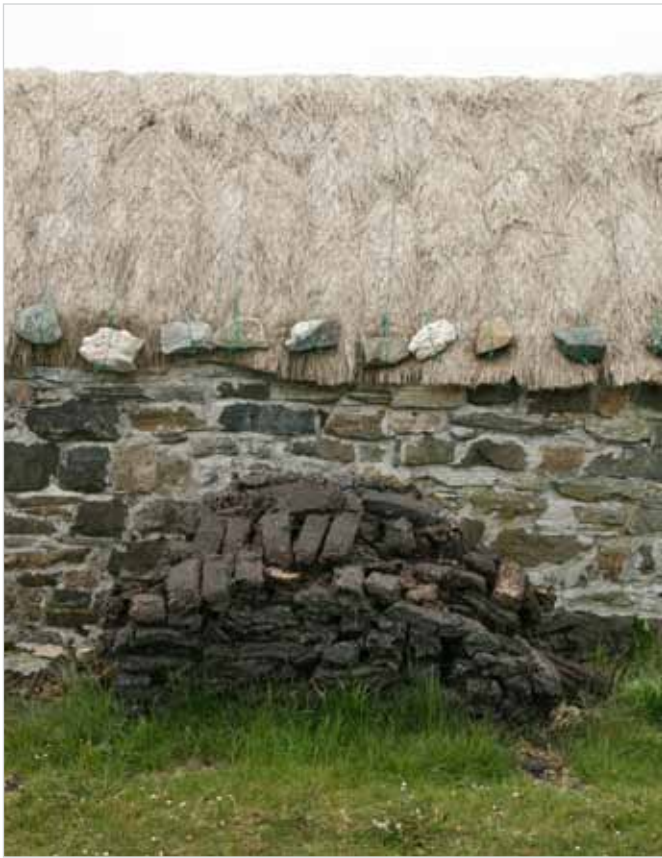
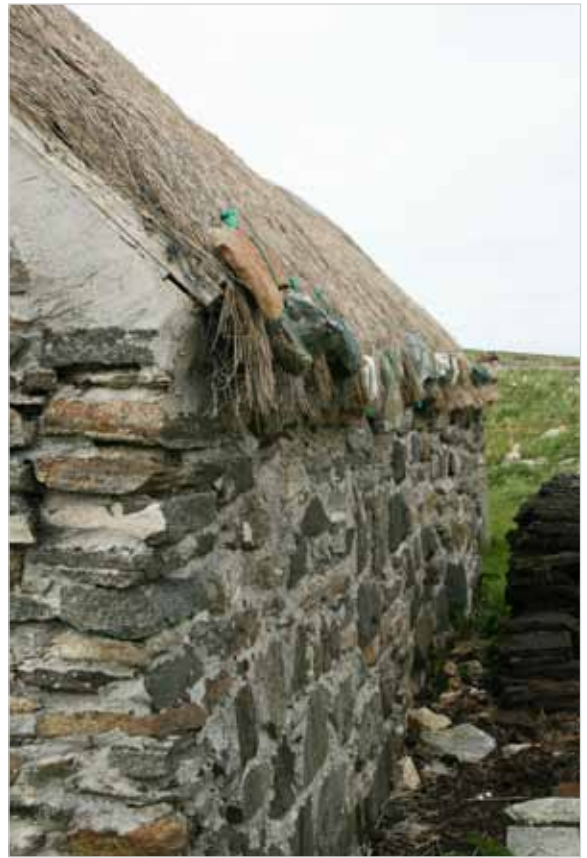
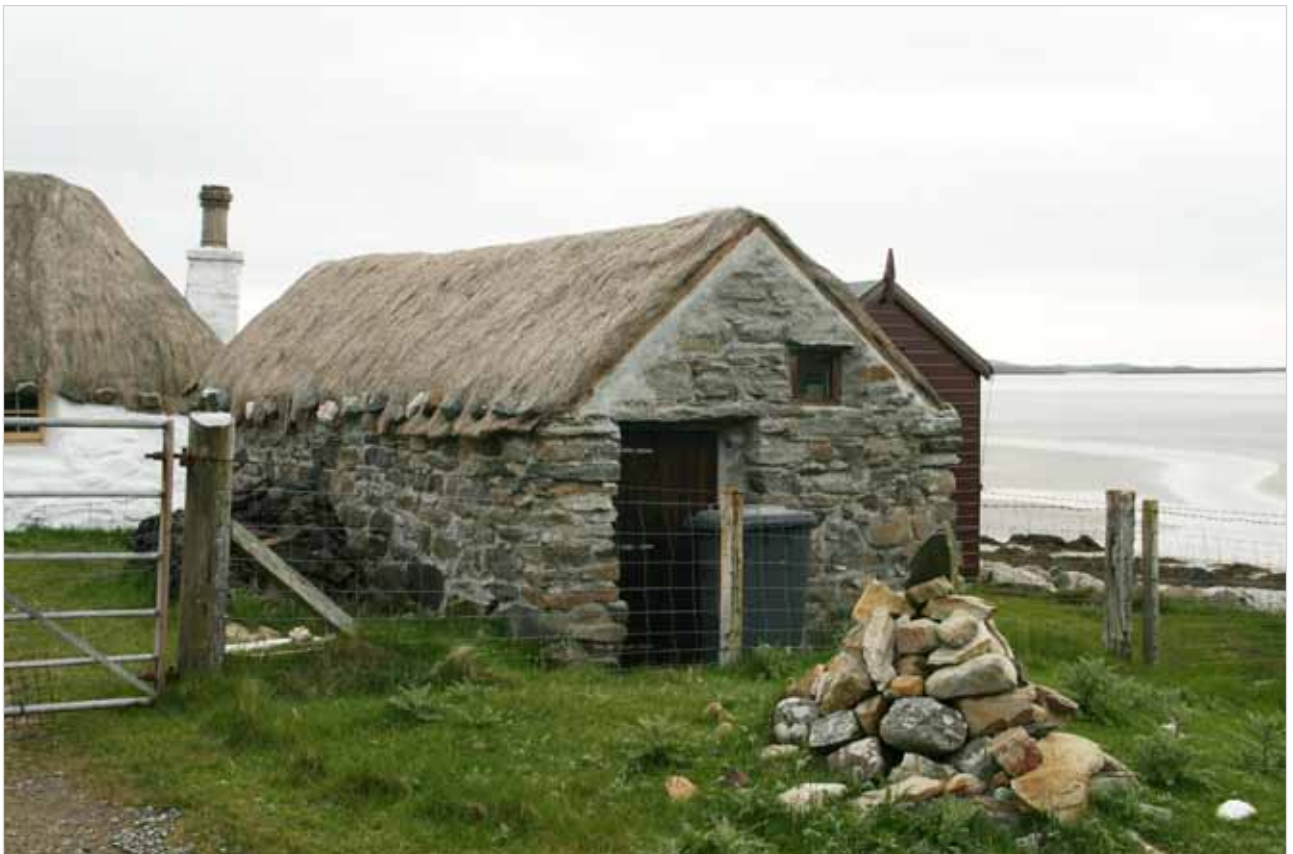
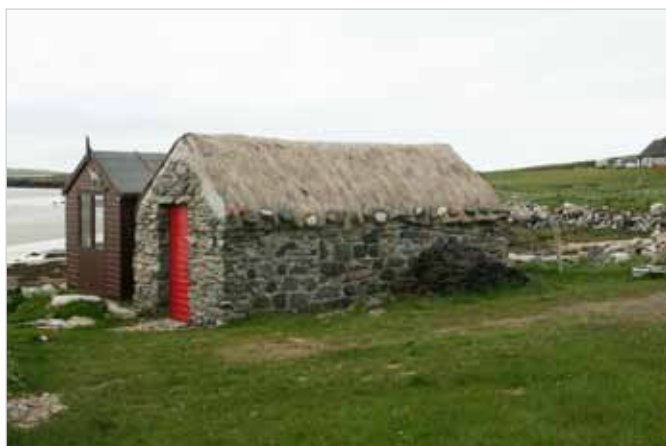
Struan Cottage Outbuilding – Western Isles

Additional Notes: ..... Listed as part of a group listing along with 'Probably 19th century' cottage, Struan Cottage (survey number 254). The listing description notes its use as a garage; however, the building currently appears to be in use as a store for the cottage, which is used as holiday accommodation. The roof of the building is thatched in marram and has a continuous marram ridge. The entire thatch has been netted, and weighted at the eaves with stones secured to the netting by string, in the same manner as the cottage.

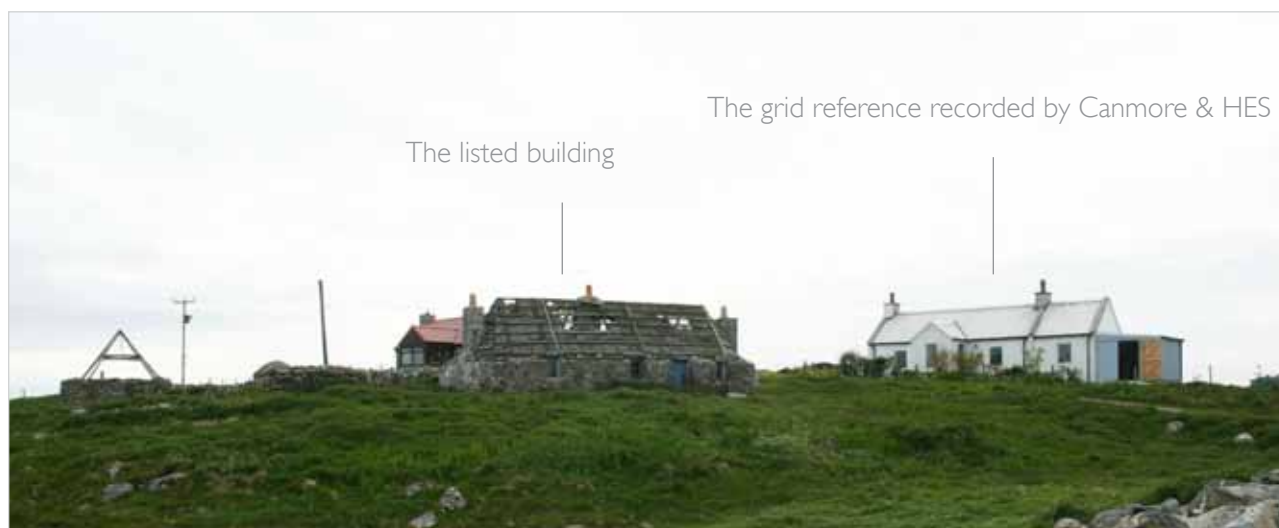
Address: ..... Ardheisker Thatched Cottage

**Additional Notes:** ..... The building is listed as having a '*muran* thatch roof, secured by ropes and stones at inner wall head'. The grid reference given by Canmore and Historic Environment Scotland for the building relates to the building on the right of the image below; however, from the listing description, and by a Buildings at Risk entry, the listed building is one shown below centre, which has been on the Buildings at Risk (BAR) register since 1997 (BAR reference number 1501). In 1996 upon inspection by BAR, it was recorded that the roof needs re-thatching. An image of the building on Canmore taken circa 2000 shows the cottage with a thatched roof. There is no longer any thatch left on the roof and the building's interior is exposed to the elements. The listed building description and grid reference should be updated accordingly.

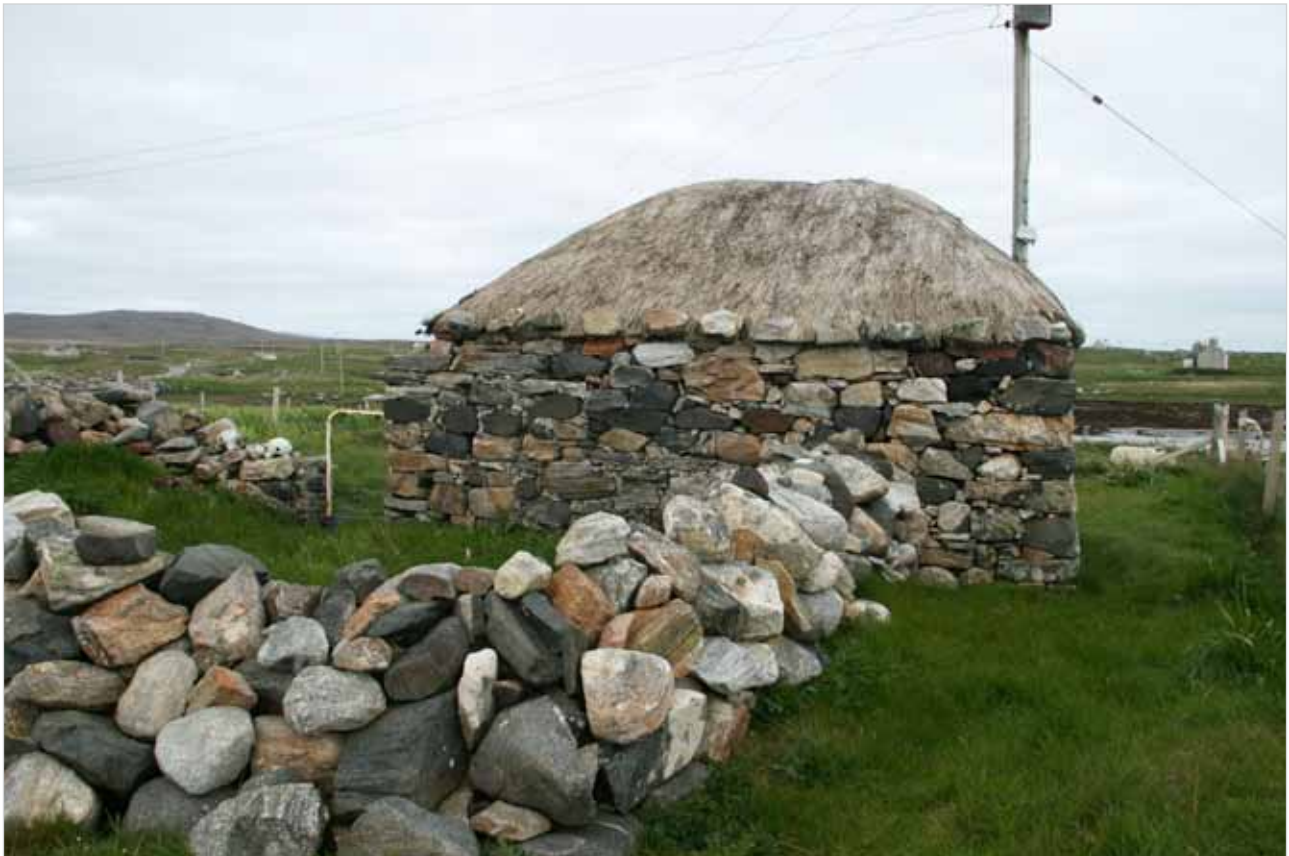
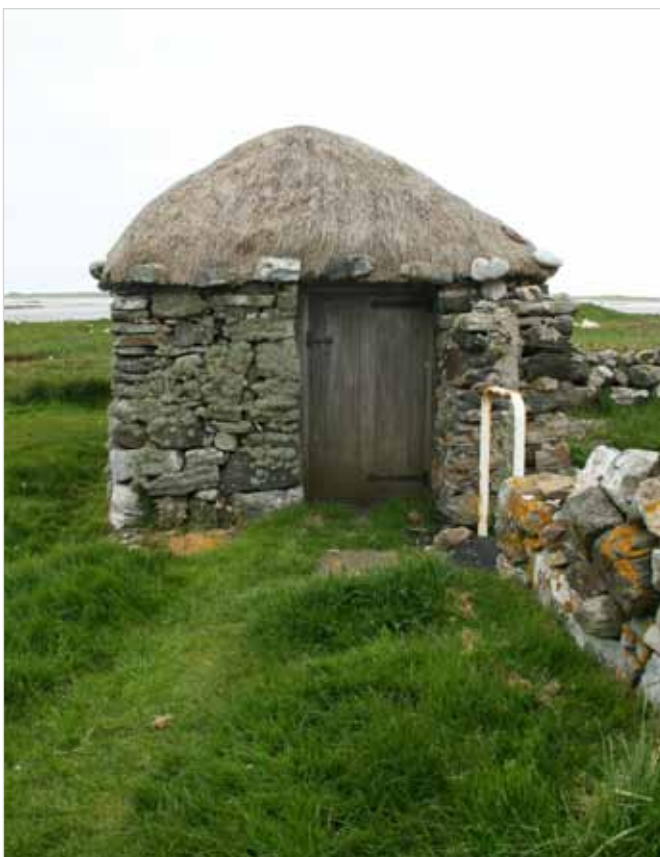
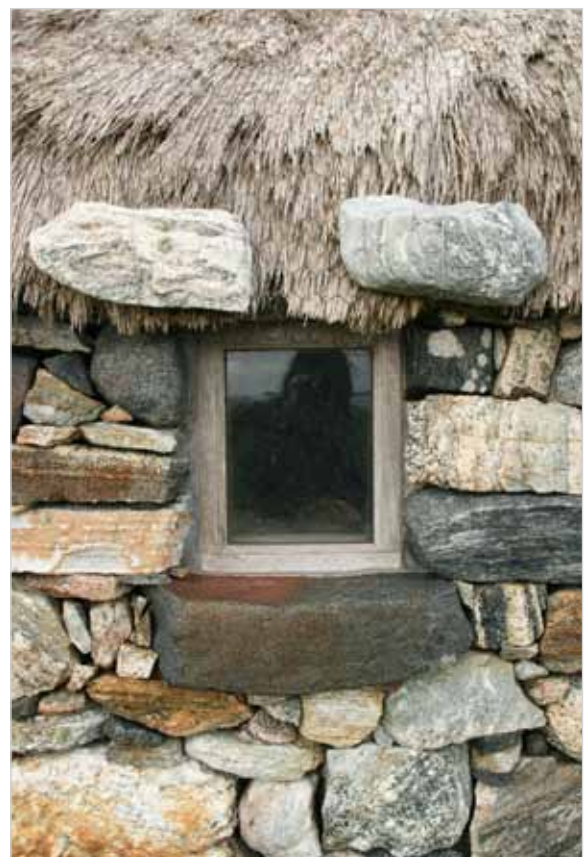
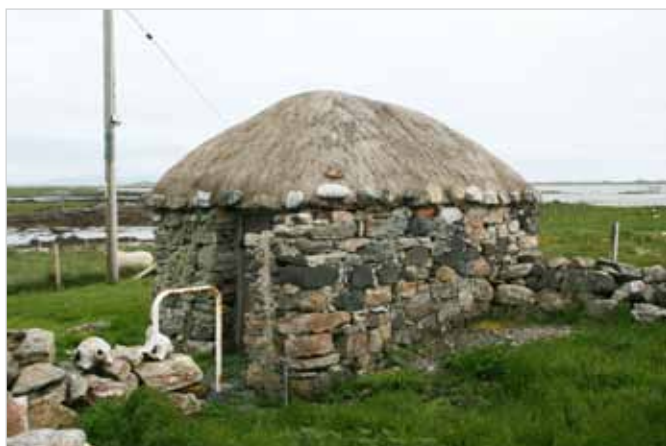
Hilltop Cottage Outbuilding – Western Isles

Additional Notes: ..... Small restored outbuilding of unknown date in the garden of a modern cottage, currently in use as a shed for storage. The building has a marram-thatched roof with a continuous marram ridge. The entire roof has been netted including across the ridge, which has been weighted along the eaves by stones secured to the netting by wire.

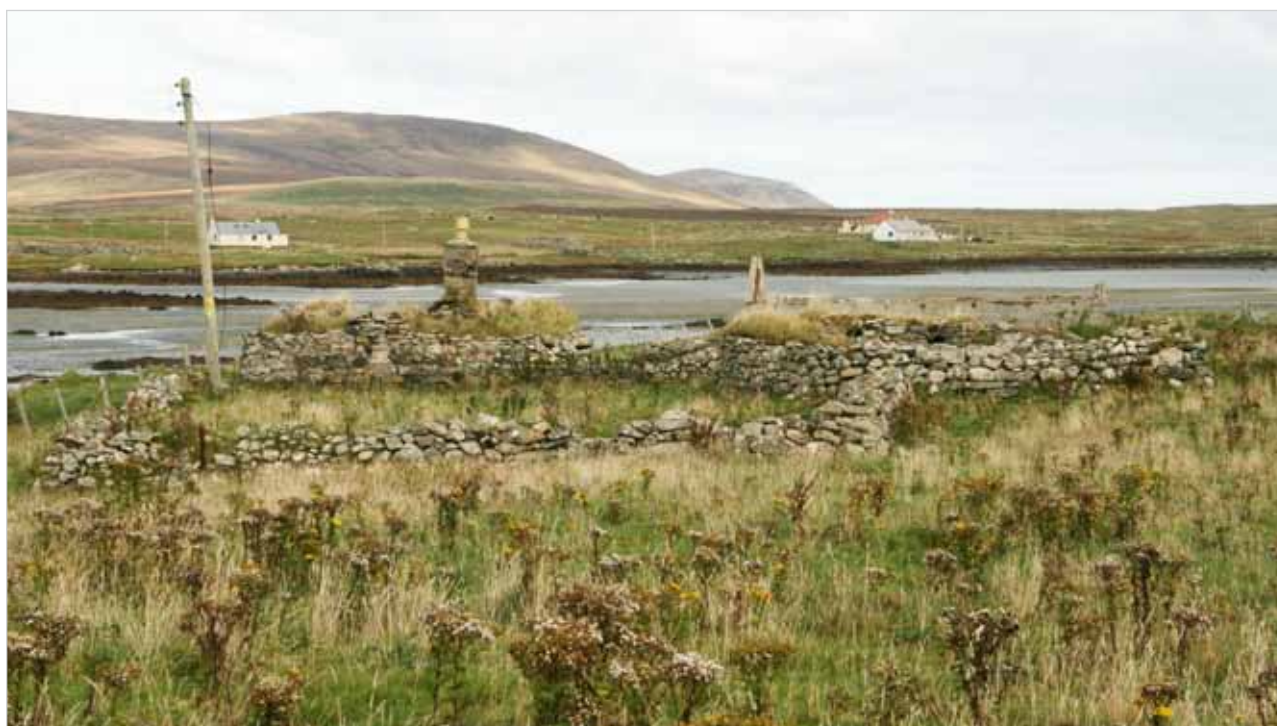
Address: ..... I 6 Knockline

Additional Notes: ..... 19th-century cottage, listed as having a '*muran thatch roof, secured with netting and ropes, stone weights over inner wallhead*'. The building is now a roofless ruin and has been on the Buildings at Risk (BAR) Register since 1996 (BAR reference number 1439), at which time it was recorded that the building was abandoned and that the roof was caving in. Upon the next visit by BAR in 2009 the roof was recorded as having caved in. The listing description for the building should be updated accordingly.

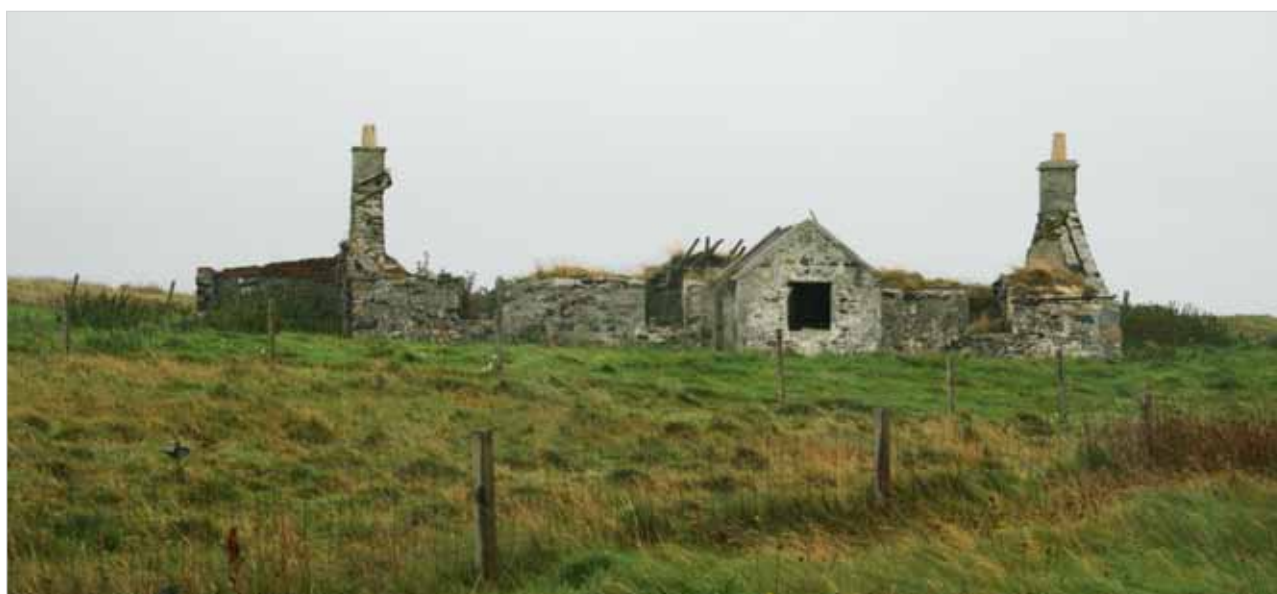
Address: ..... Druim Dubh  
..... Paiblesgarry  
..... Isle of North Uist  
.....  
Local Council: ..... WESTERN ISLES  
.....  
Grid Reference: ..... NF 73508 69286  
Date of Visit: ..... 22/09/2014  
Listing Category: ..... C  
Date Listed: ..... 05/10/1971  
Listed Building Number: ..... 17580  
Canmore ID: ..... 238318  
Building Type: ..... Cottage  
Use: ..... n/a  
Occupancy: ..... Ruin  
Buildings At Risk: ..... Yes

**Additional Notes:** ..... Probably 19th-century, 'unusually long' cottage, listed as having 'muran thatch roof secured by netting, stone weights over inner wallhead'. The building has been on the Buildings at Risk (BAR) Register since 1996 (BAR reference number 1500), at which time the building was recorded as being 'vacant and decaying'. In 1996, the roof was recorded as having collapsed over the left-hand bay, yet by 2009 BAR recorded the whole thatched roof had collapsed. The cottage remains a roofless ruin, with what appears to be some heavily degraded thatching material on what is left of the wallheads. The listing description for the building should be updated accordingly. ....

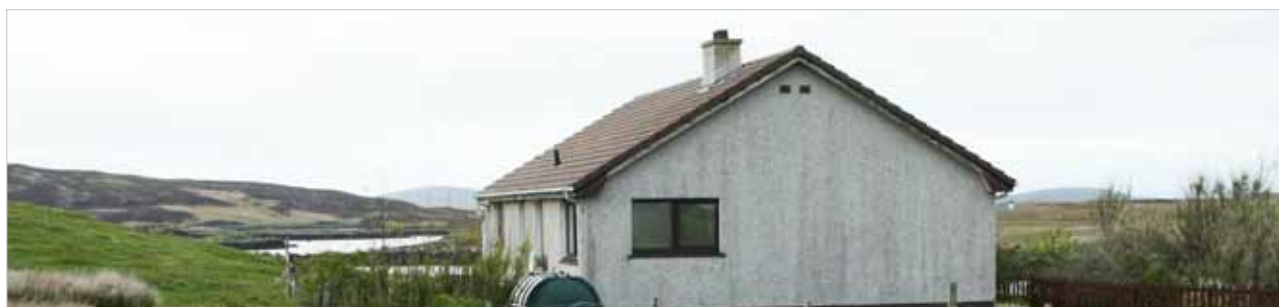
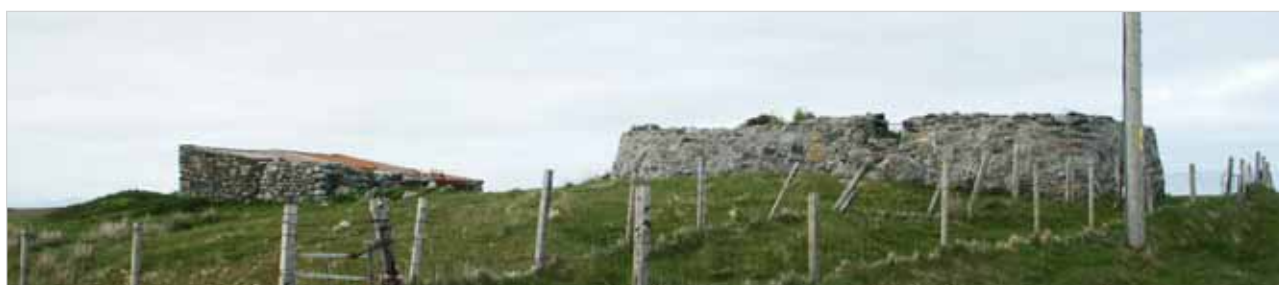
Address: ..... 29 Locheport

**Additional Notes:** ..... The grid reference recorded by this buildings' listing and by Canmore refers to a modern building on the site at 29 Locheport (grid reference NF 84910 63486); however, the BAR entry clearly identifies a ruin to the west of that as being the listed building. The 19th-century cottage is listed as having a '*heather thatch roof, secured with netting, stone weights over inner wall-head*'. The building has been on the Buildings at Risk (BAR) Register since 1996 (BAR reference number 1509), at which time it was already recorded to be a roofless shell. By inspection in 2008, BAR recorded that the interior had been cleared and only the external walls survived. The listing description and the grid reference for the building should be updated accordingly. ....

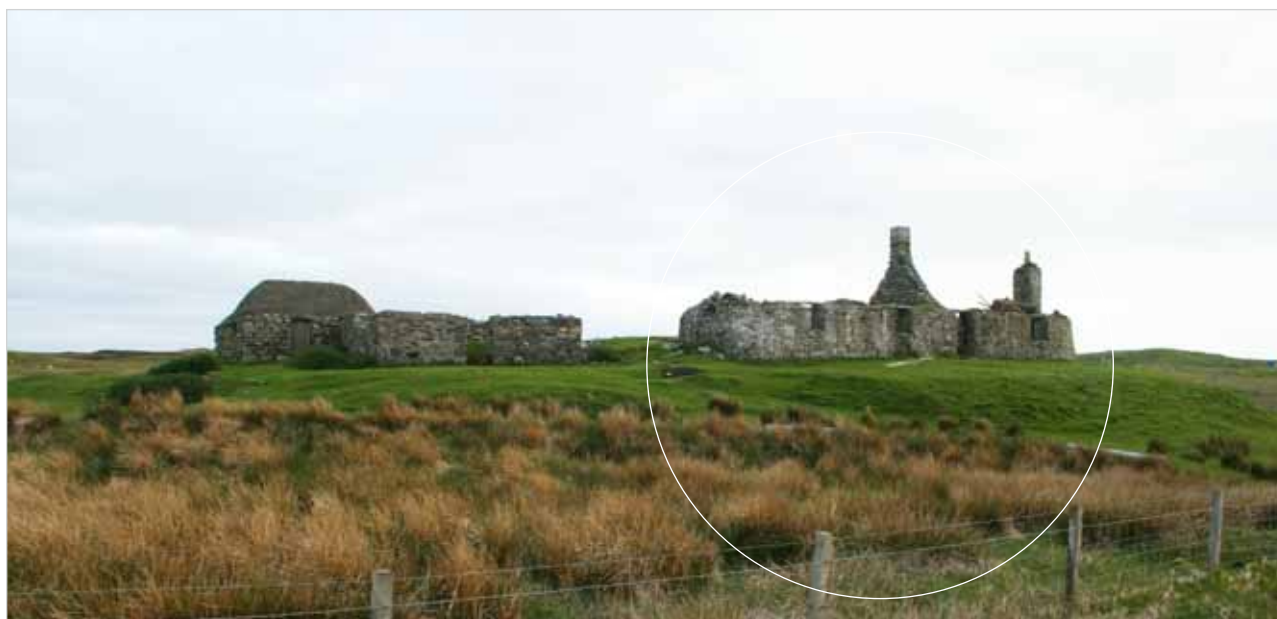
Address: ..... 9 Locheport

**Additional Notes:** ..... The cottage is listed as being a 'single storey 4-bay Hebridean-type thatched cottage' with a 'heather thatch roof secured with netting and stone weights; wallhead mainly covered by thatch'. The building is now a roofless ruin and has been on the Buildings at Risk (BAR) Register since 1996 (BAR reference number 1665), at which time it was recorded that the cottage had been unoccupied since 1983 and that part of the roof had caved in. By BAR inspection in 2009 most of the thatched roof had caved in and in 2010 BAR recorded the cottage to be roofless. Currently, there remains a small amount of collapsed roof structure and thatching material visible within the building shell. The listing description for the building should be updated accordingly.....

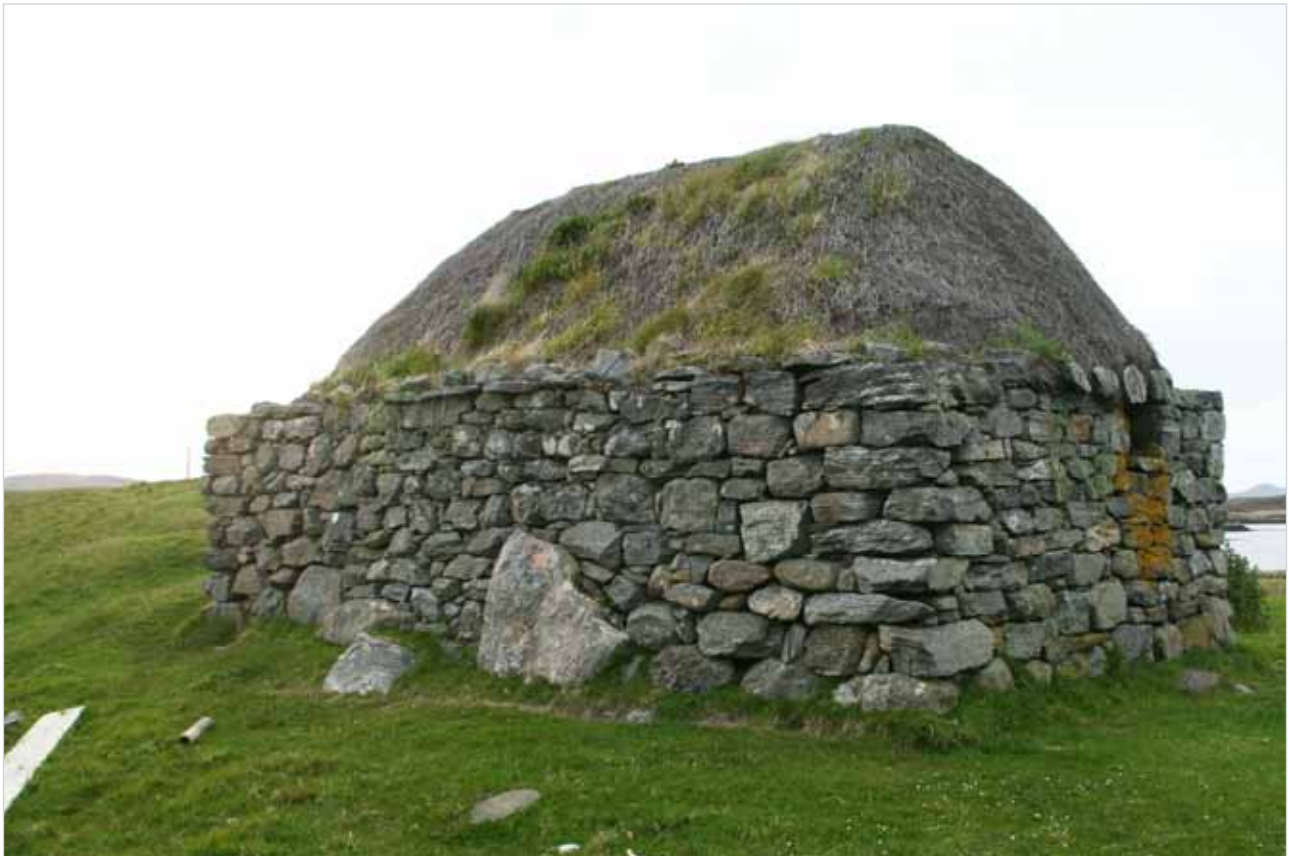
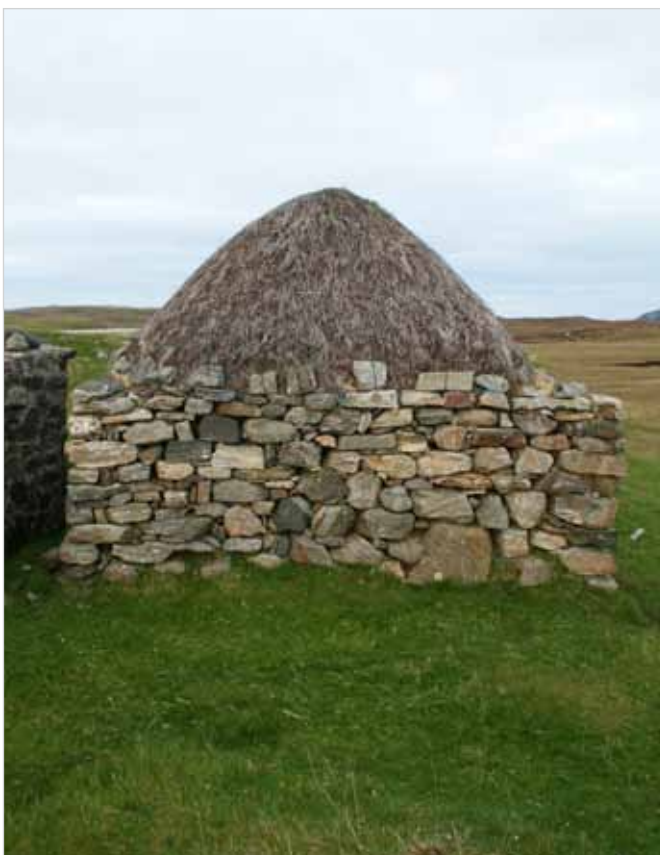
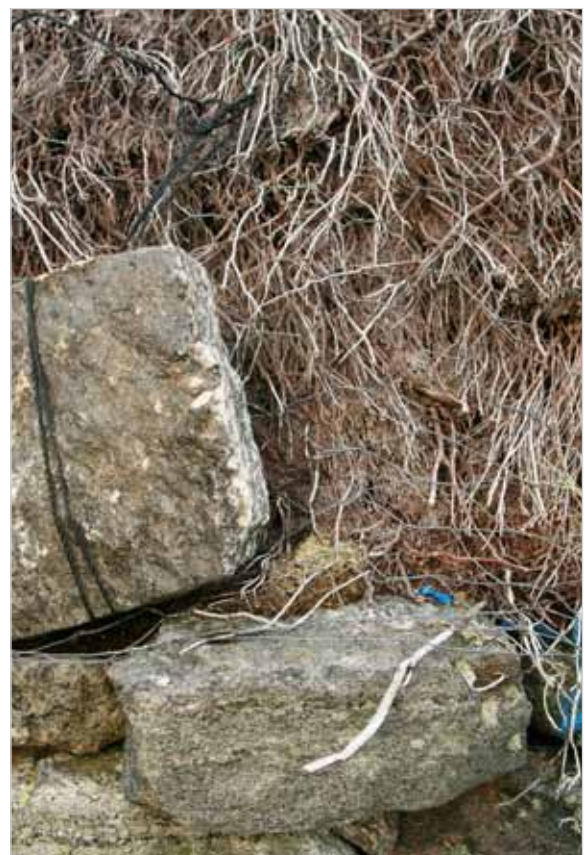
9 Locheport Outbuilding – Western Isles

Condition of Thatch: ..... Fair

the thatch on the south elevation, and a small

amount of moss growth on the north elevation.

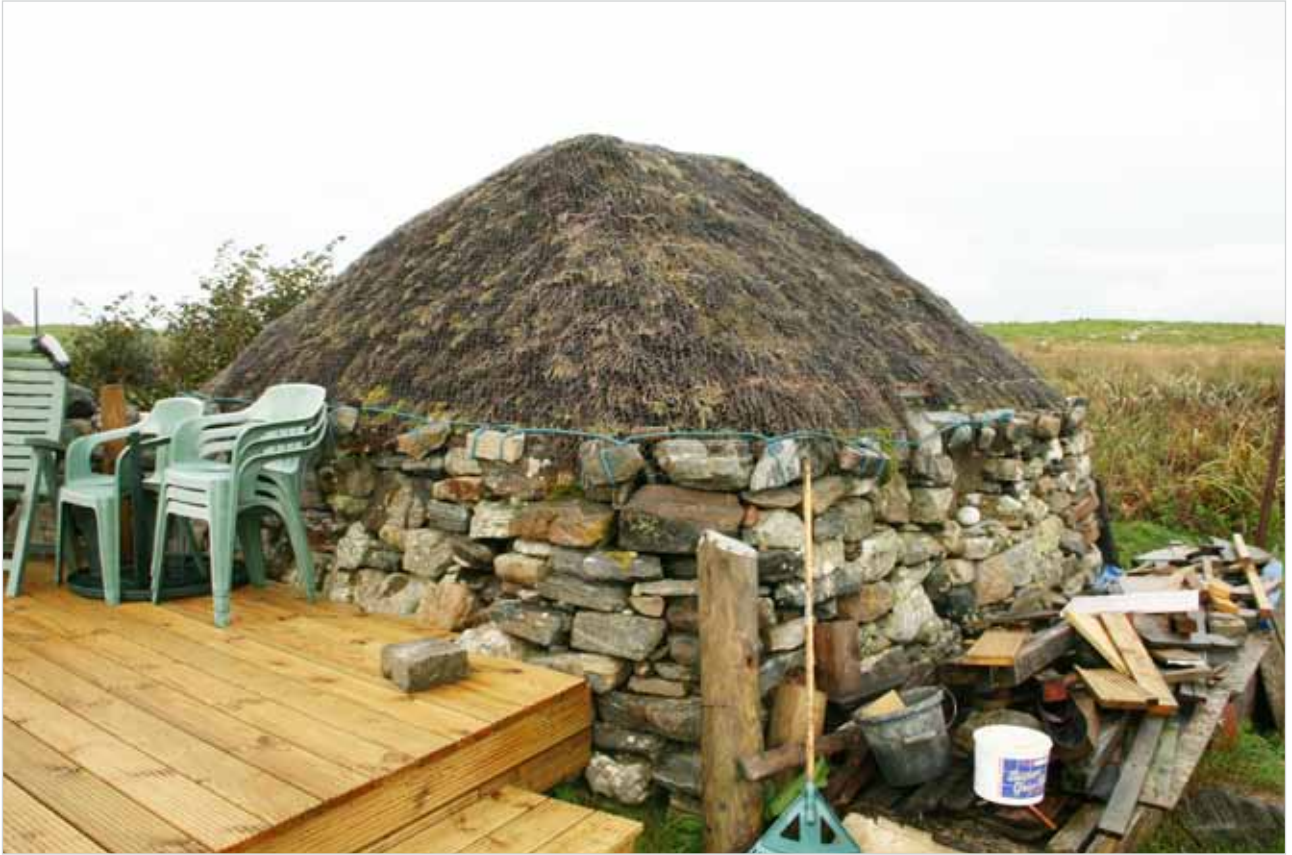
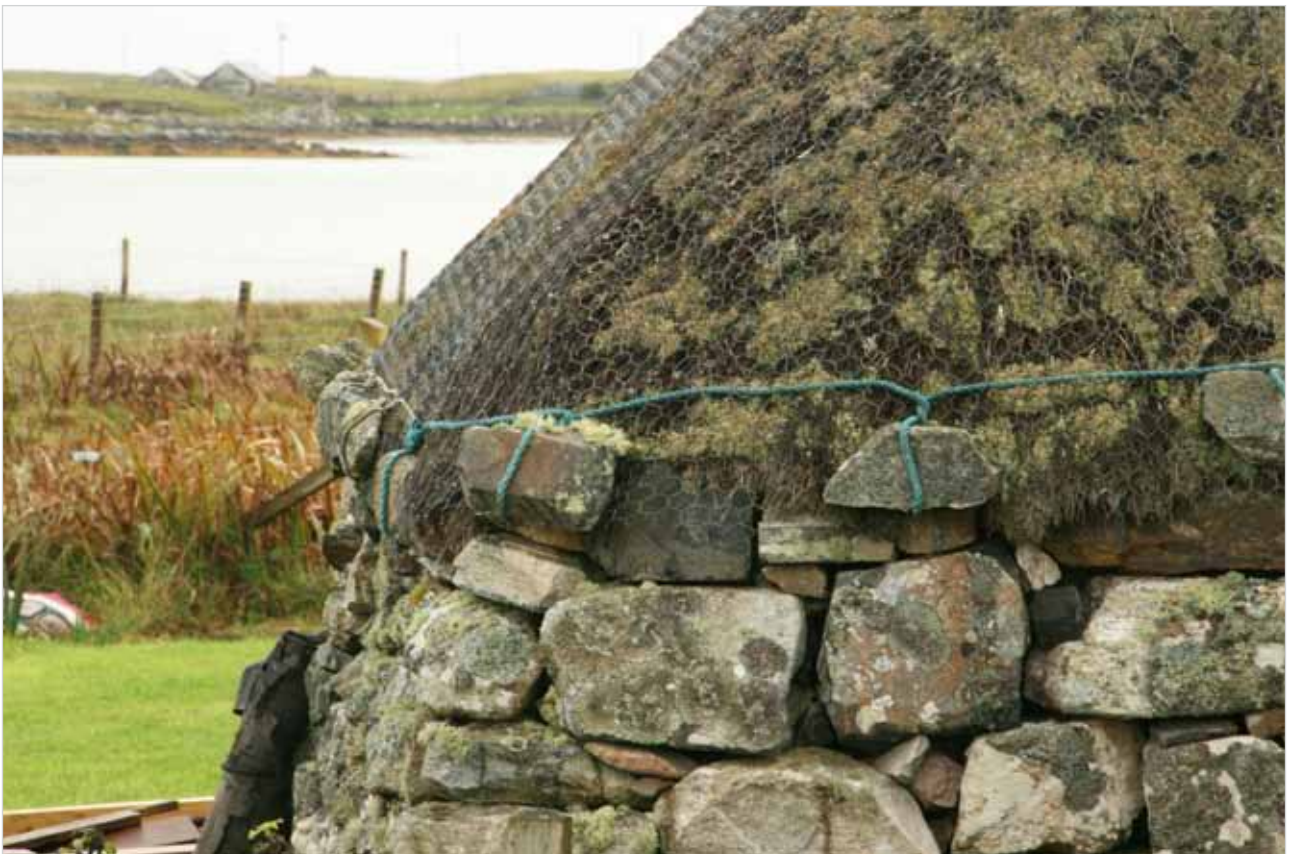
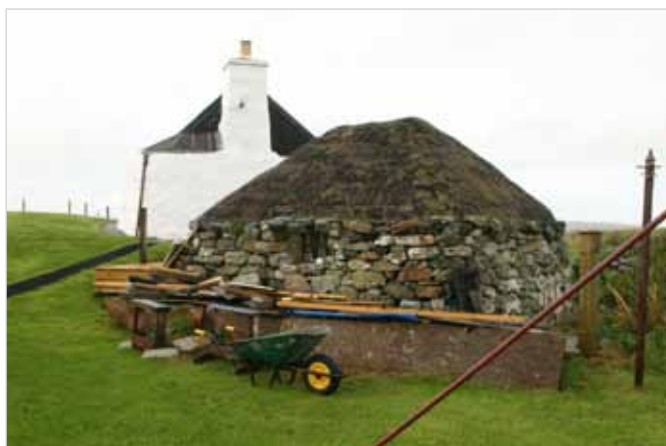
Samhla View – Western Isles

Condition of Thatch: ..... Fair

Additional Notes: Thatched outbuilding in the garden of a once-thatched cottage and byre (survey number 264). The building is thatched in heather with a continuous heather ridge. The entire roof is netted, including across the ridge, which has been weighted along the eaves with stones, secured to the netting with a continuous string of thin rope passed through the holes of the net. There is an amount of mossy vegetation growth across the surface of the thatch.

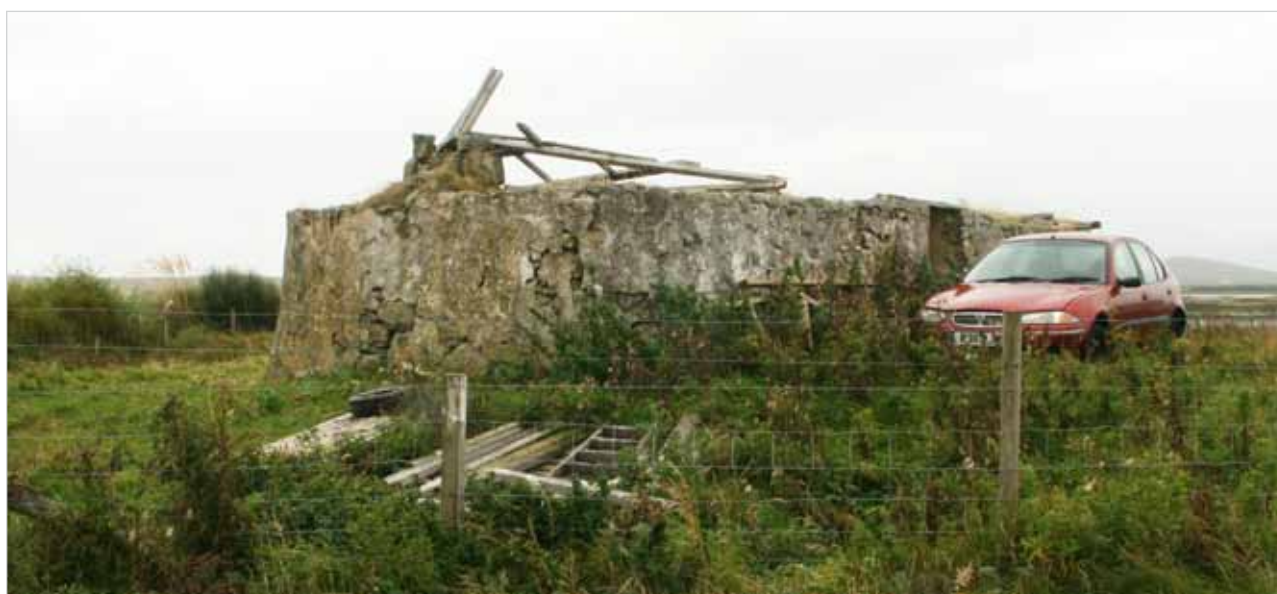
Address: ..... Thatched Cottage

**Additional Notes:** ..... Listed as a 'Skye-type thatched cottage' with 'muran thatch roof, reaching over eaves, and secured with stone, weights'; however, this building is now a roofless ruin and no thatch remains. The building has been on the Buildings at Risk (BAR) Register since 1996 (BAR reference number 1430). Upon BAR inspection in 1998 the building was recorded as being 'empty and becoming derelict, though it retains its thatched roof'; however by the next BAR inspection in 2009 the building was recorded as being 'a roofless ruin'. The Canmore maps shows the wrong grid reference for the building (NF 85230 58996), yet BAR have the building's location correct. The listing description should be updated accordingly.....

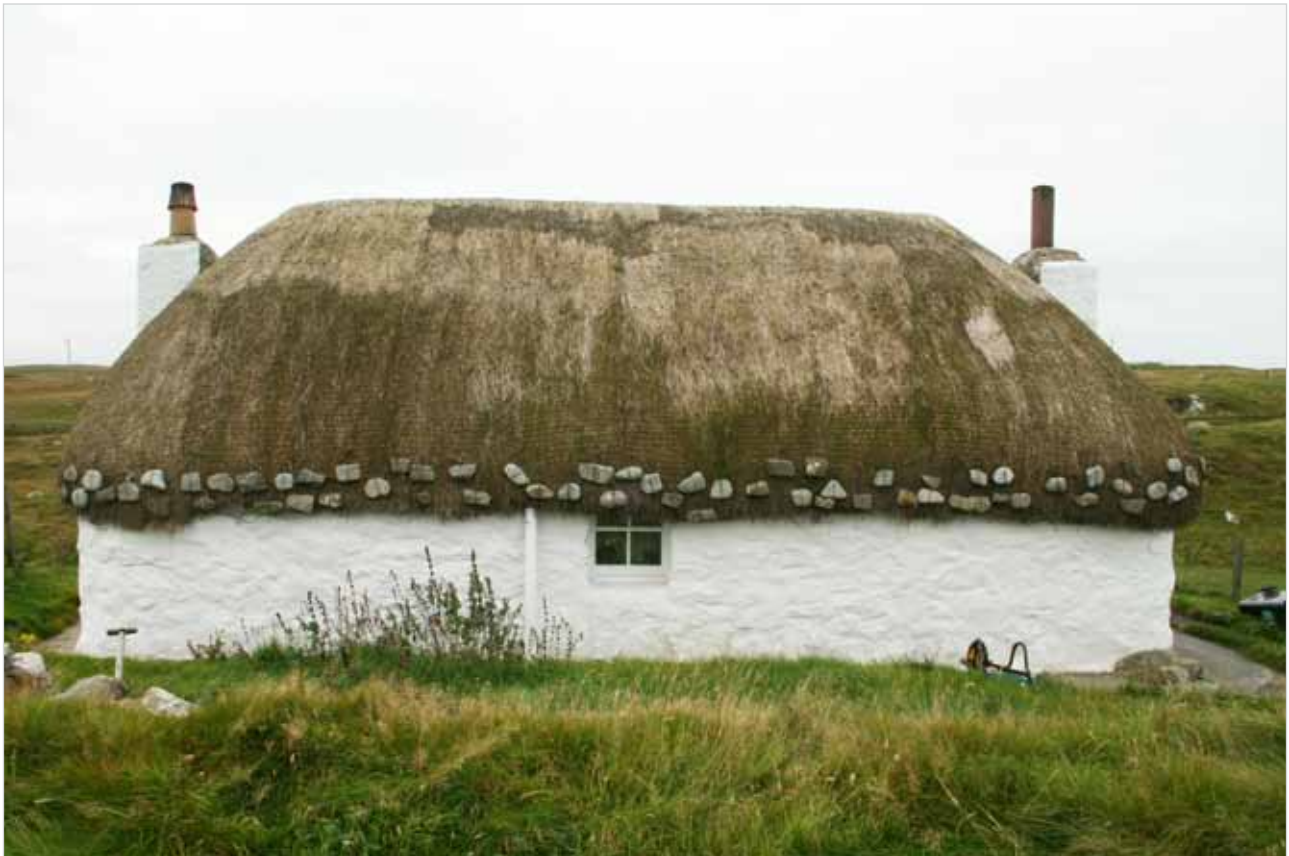
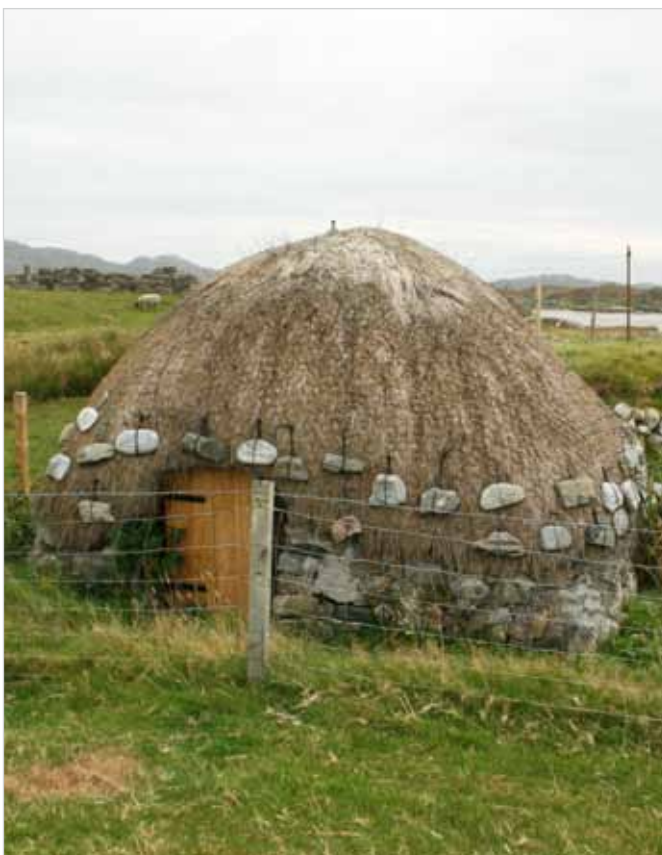
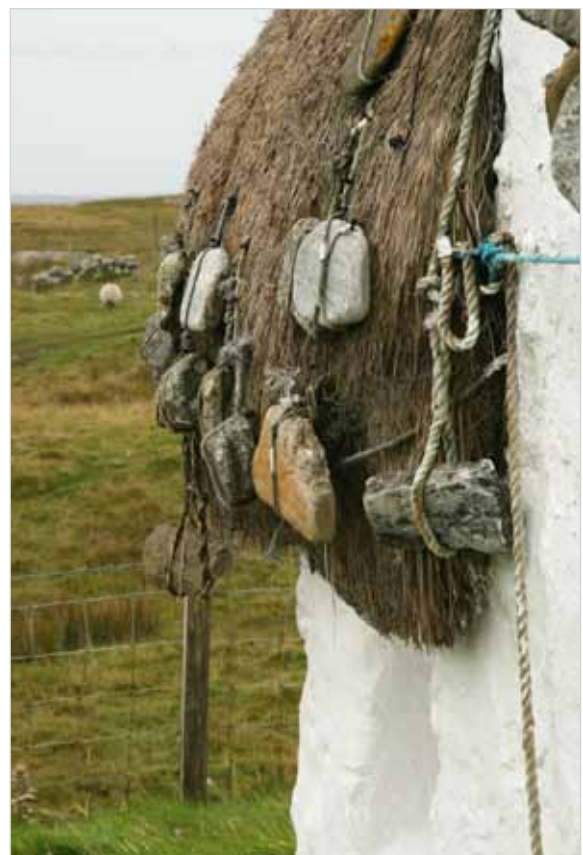
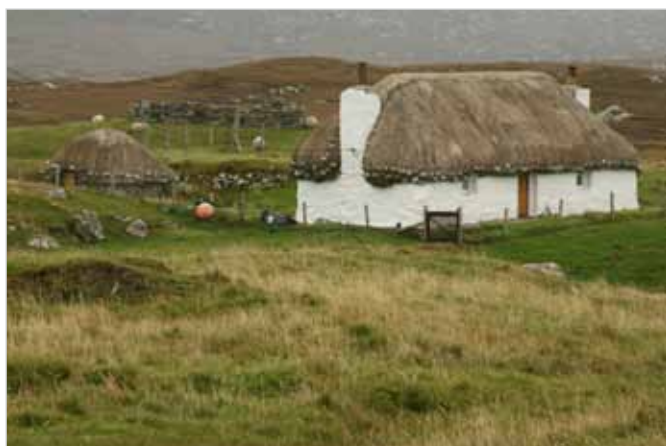
Thatched Cottage – Western Isles

Late 19th/early 20th-century cottage, listed as having a 'muran thatch roof reaching over eaves, secured with netting and stone weights'. There is also a 'thatch-roofed outbuilding to north', which is also part of the listing. Both roofs are thatched in marram and have continuous marram ridges, as well as being entirely netted, including across the ridge. The netting has been weighted on both buildings by two rows of stones just above the eaves, and a single row of stones around the chimney stack at either end of the cottage, which have been secured to the netting by metal wire and string. There is a small amount of green algae-like

vegetation growth to the surface of the thatch on the rear elevation of the cottage and some thatch replacement/repairs appear to have taken place in the past, made apparent by the obvious difference in colour of the thatch in places.
